PREPARATION OF VULNERABILITY INDEX REPORT OF THE STATE

GIS MAPPING OF LANDSLIDE VULNERABLE AREAS OF NORTH SIKKIM

GIS MAPPING OF LANDSLIDE VULNERABLE AREAS OF EAST SIKKIM

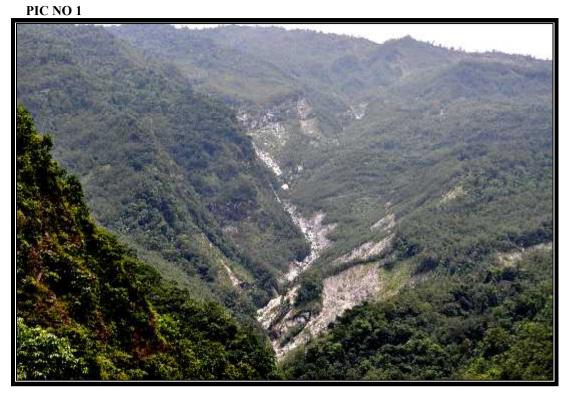
FAULT CONTROLLED RANG RANG LANDSLIDE, NORTH SIKKIM

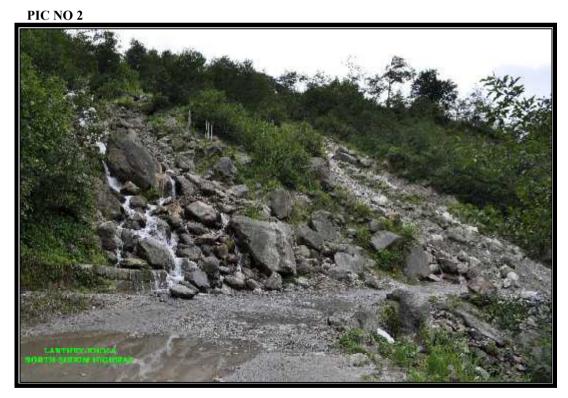
DEBRI FLOW – LANTHEY KHOLA SLIDE, NORTH SIKKIM

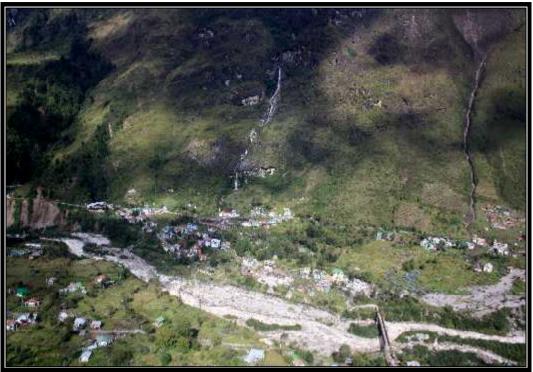
FLASHFLOOD & LANDSLIDE AT LACHUNG: POST 18/9/2011 EARTHQUAKE

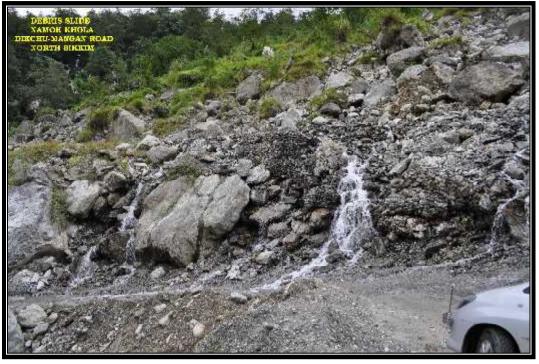
DEBRIS SLIDE AT NAMOK KHOLA-DIKCHU-MANGAN ROAD, NORTH SIKKIM

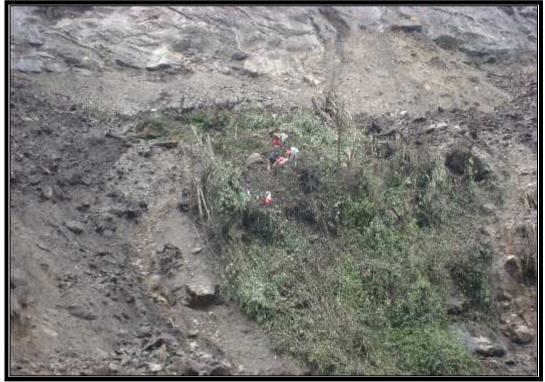
DEBRIS FALL-BAY-DZONGU, NORTH SIKKIM

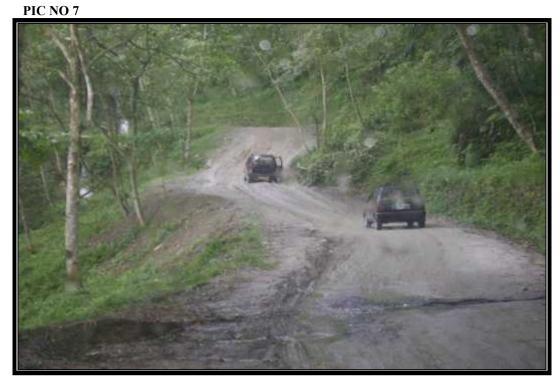
INSTABILITY ALONG RANIPOOL – PAKYONG ROAD-ANDHERI SLIDE

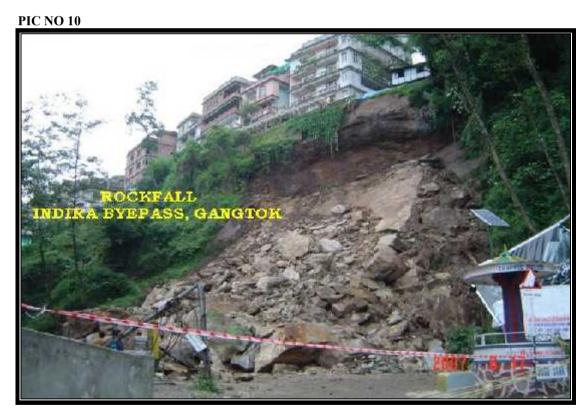
ROCK FALL INDIRA BYE-PASS, GANGTOK, EAST SIKKIM

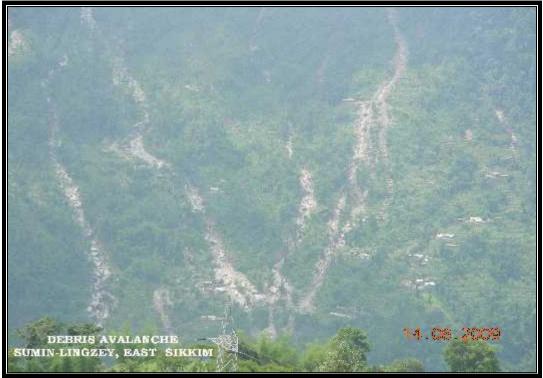
DEBRIS AVALANCHE, SUMIN-LINGZEY, EAST SIKKIM

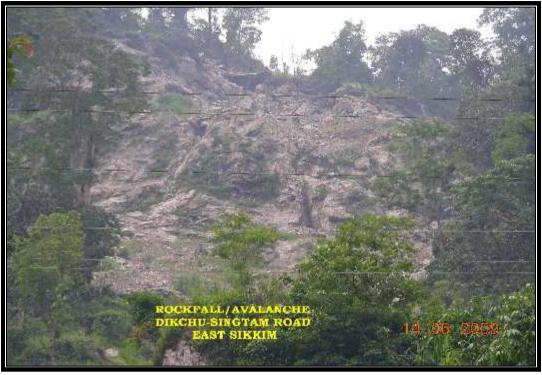
ROCK FALL / AVALANCHE DIKCHU-SINGTAM ROAD, EAST SIKKIM

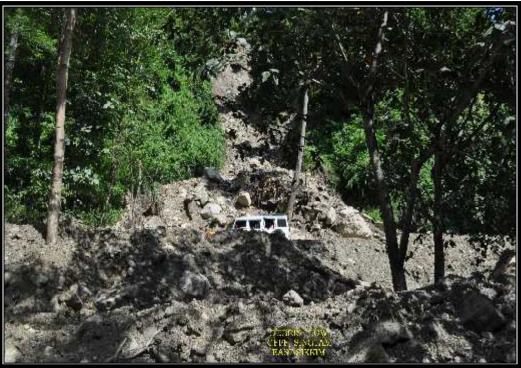
DEBRIS FLOW -- CHISO PANI LANDSLIDE ALONG NH 31 A, NEAR SINGTAM, EAST SIKKIM

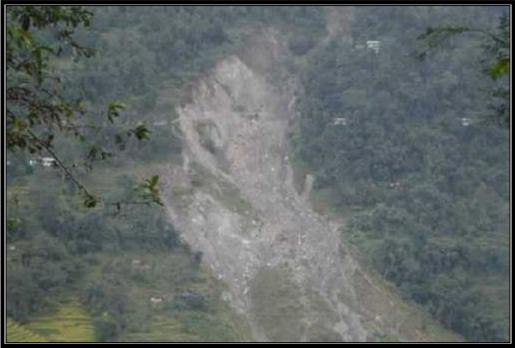
FAULT CONTROLLED BOJECK SLIDE, WEST SIKKIM

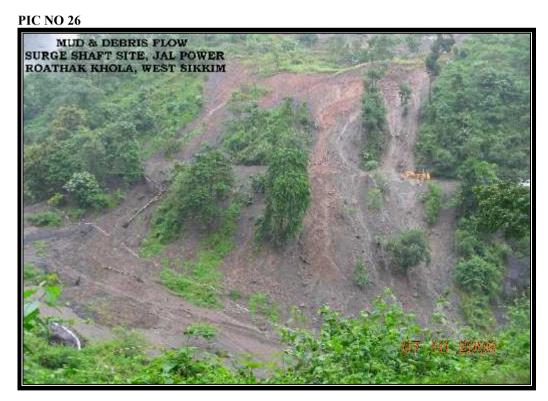
MUD & DEBRIS FLOW, SURGE SHAFT SITE, JAL POWER, ROATHAK KHOLA, WEST SIKKIM

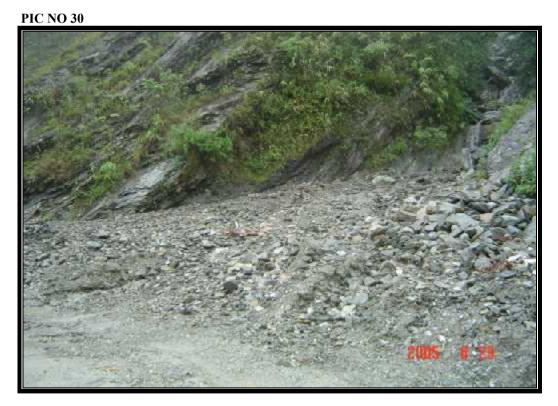
CHOKED CAUSEWAY AT NARAK JHORA SLIDE AREA, SOUTH SIKKIM

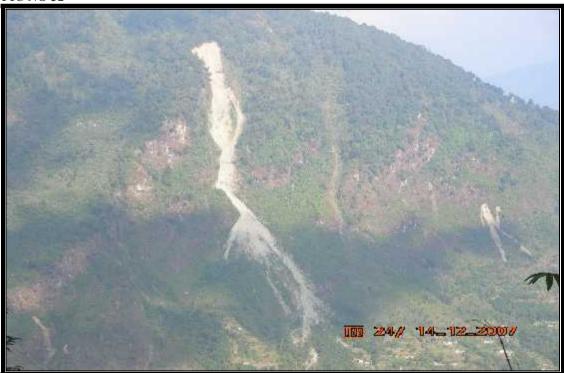
BAGHDARA DEBRIS AVALANCHE, BURRIED SATAM VILLAGE, SOUTH SIKKIM

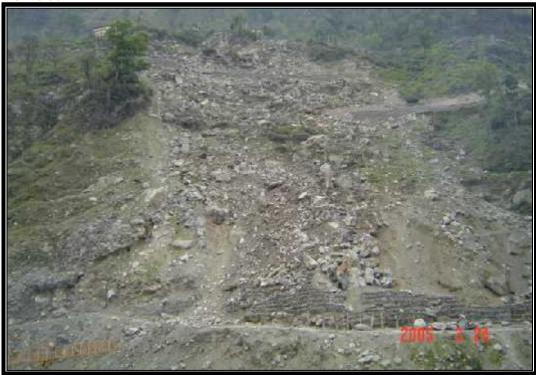
GABIONS OVER UNSTABLE SLOPE, DAM SITE, NHPC STAGE V, SOUTH SIKKIM

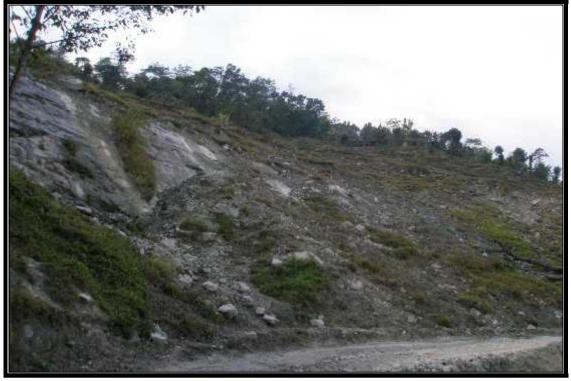
SLOPE FORMING MATERIAL ON DOWN DIP ROCK SLOPE, SOUTH SIKKIM

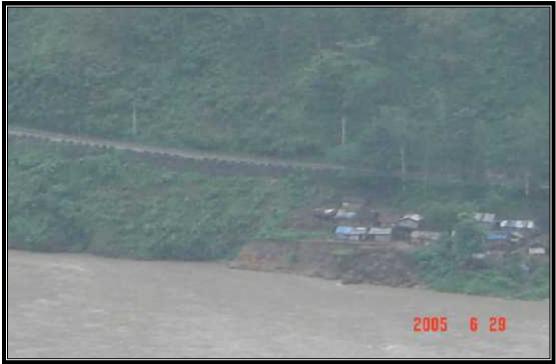
SCOURING BY RIVER TEESTA WHEN IN SPADE, RONGPO IBM, EAST SIKKIM

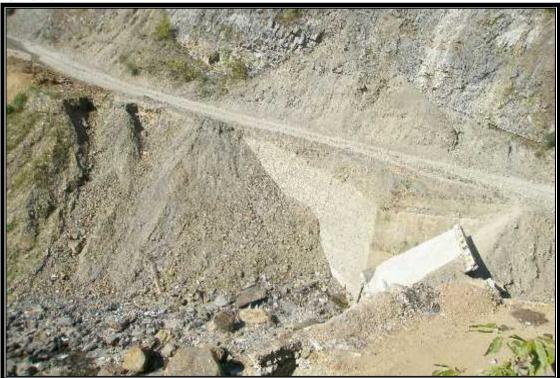
COLLAPSED BRIDGE ON NAMCHI - BUL ROAD, NEAR SALEBONG, SOUTH SIKKIM

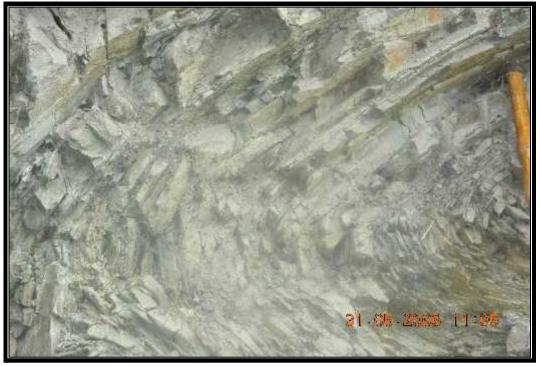
FOLDED AND SHEARED ROCK FORMATION, SOUTH SIKKIM

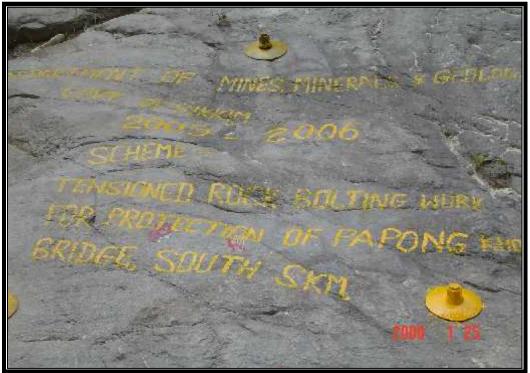
TENSIONED ROCK BOLTING BY DMM&G AT LEFT BANK OF PABONG KHOLA SOUTH SIKKIM
