**PROJECT PRE-FEASIBILITY REPORT (PPR)
ON
LANDSLIDES RISK MITIGATION & MANAGEMENT IN SIKKIM
(Phase-I)**

**NATIONAL LANDSLIDE RISK MITIGATION
PROGRAMME
(NLRMP)**

**SUBMITTED BY
SIKKIM STATE DISASTER MANAGEMENT AUTHORITY
(SSDMA)**

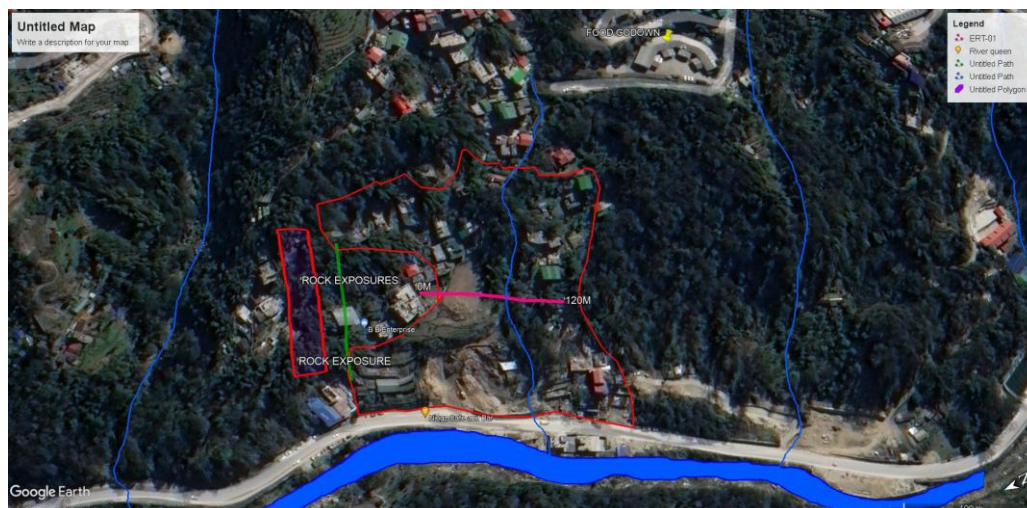
Figure 2: Lumsey Landslide (Lat 27°19'32.48"N Long 88°35'48.20"E)

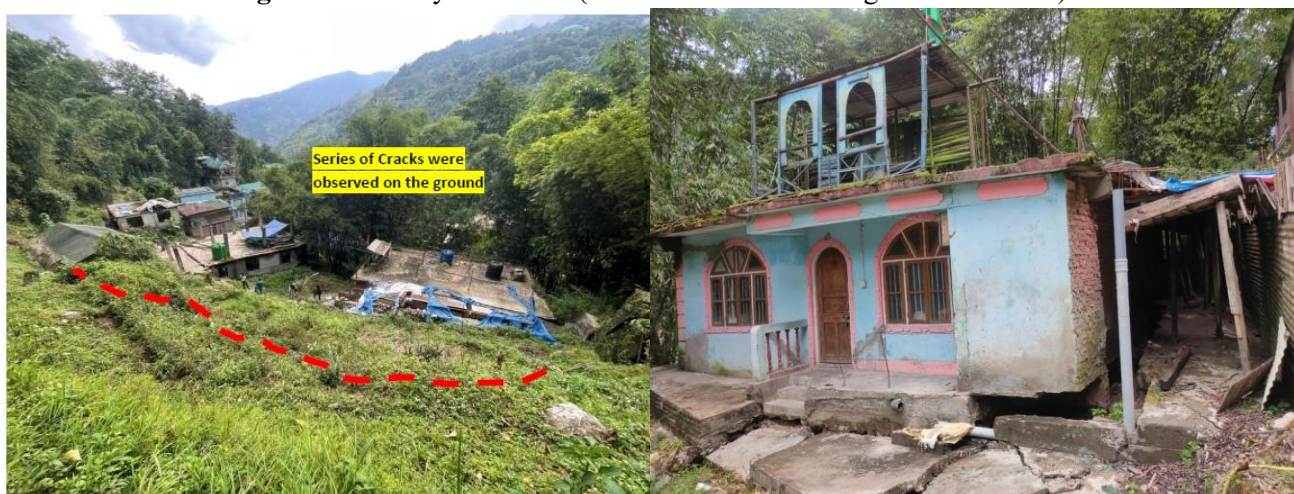
Photo Plate 1: Lumsey Subsidence Zone, Gangtok, Sikkim

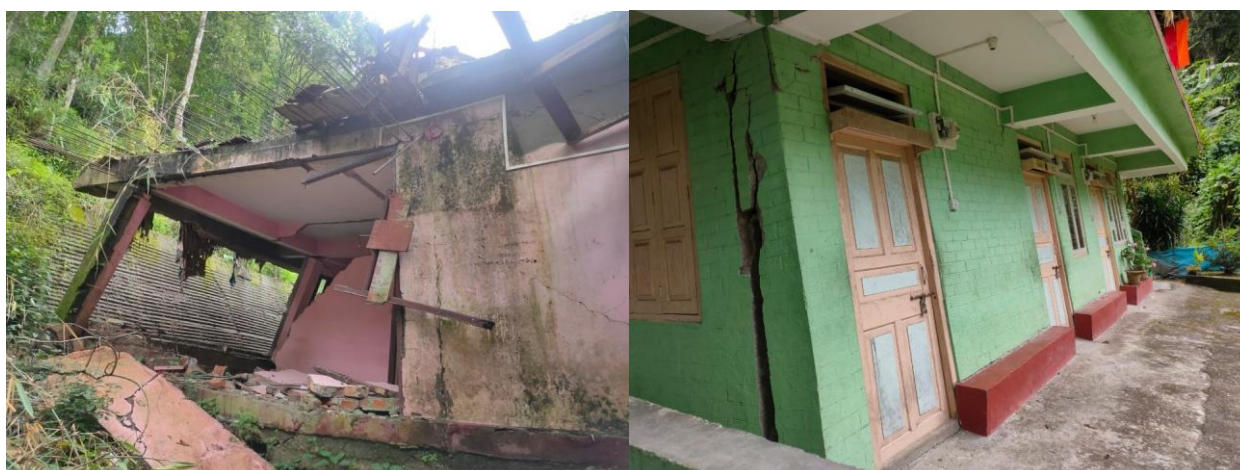
Photo Plate 2: Lumsey Subsidence Zone, Gangtok, Sikkim

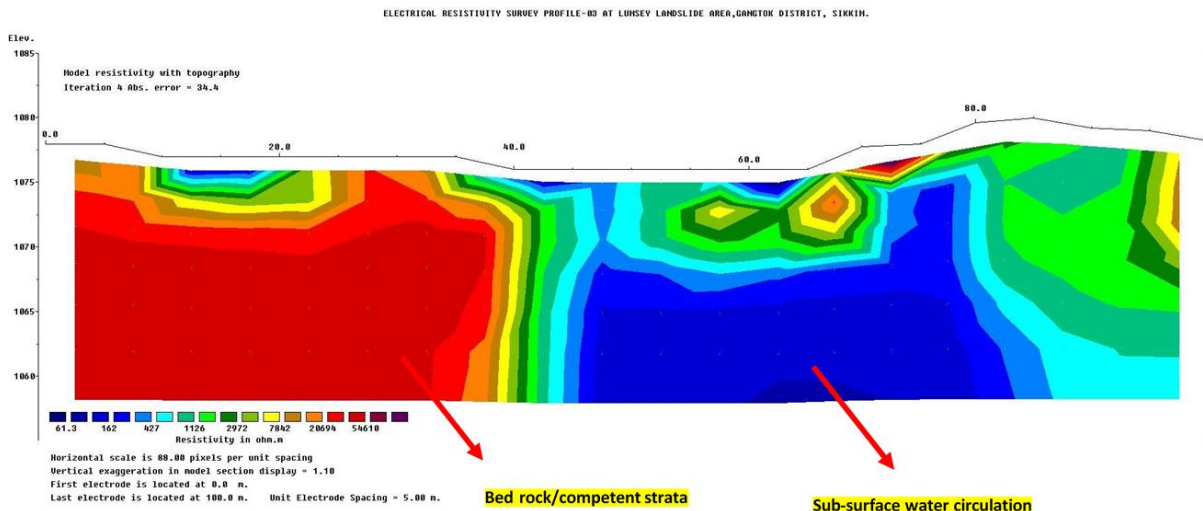
ERT Survey Profile of Site 3 (PS03-PS03') at Lumsey Landslide, Gangtok

Medium thick soil overburden overlain by Garnetiferous mica schist intermixed with gneissic rock with occasional quartz veins are inferred in profiles. Multi-electrode resistivity survey with Schlumberger-Wenner array was carried out in profile sections. Observation from 2D-inversion resistivity in the profile sections shows that the top layer consists of soil overburden intermixed with weathered/fractured rock fragments underlain by highly to moderately weathered Garnetiferous mica schist intermixed with gneissic rock with occasional quartz. Further, all the profile shows highly saturated zone of soil intermixed with rock fragments exists with variable depths ranging from 0m-15m and 0m – 20m are seen in the tomography.

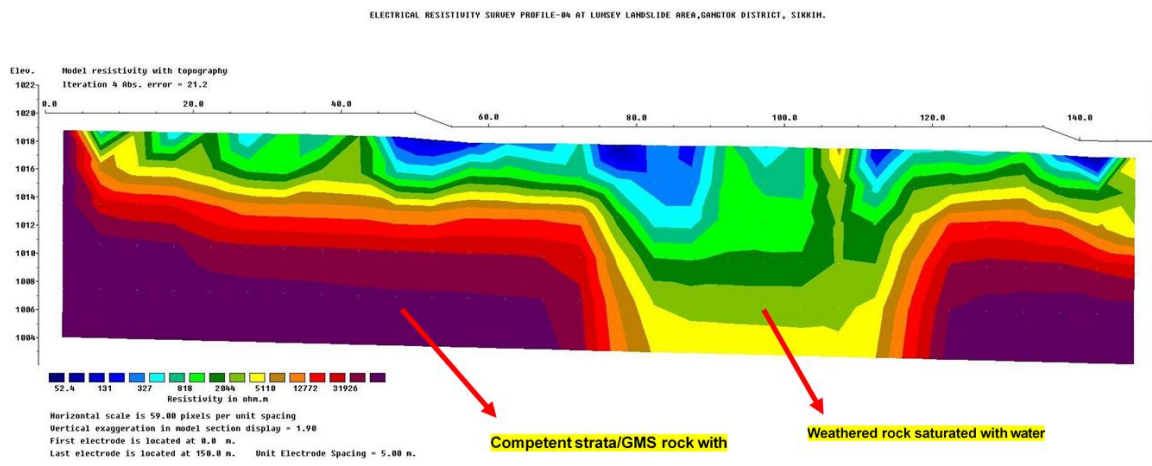
ERT Survey Profile of Site 4 (PS04-PS04') at Lumsey Landslide, Gangtok

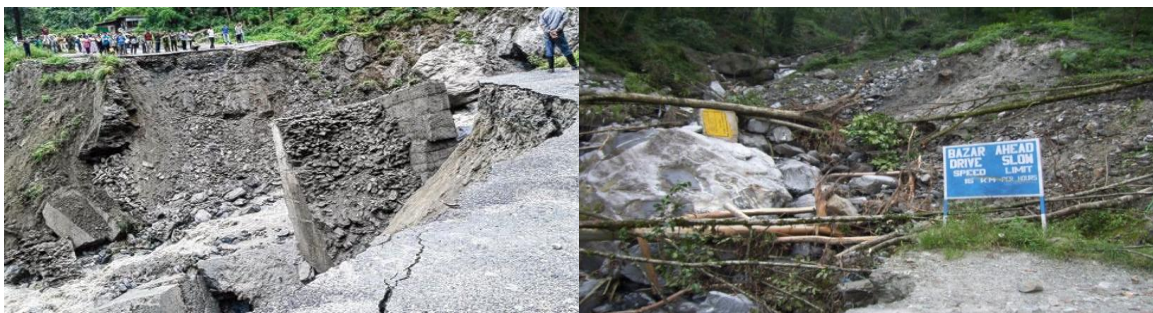
Photo Plate 6: Raffong Khola along Mangan Landslide

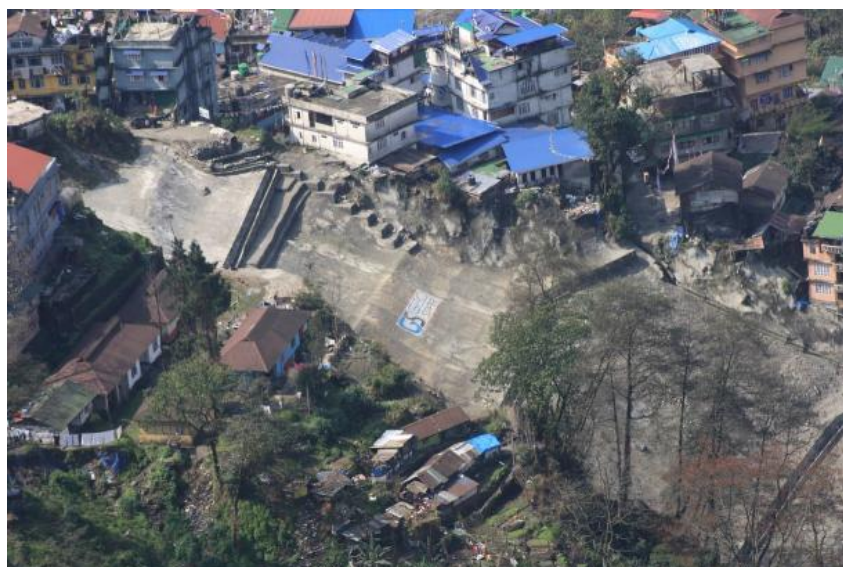
Photo Plate 7: Treatment of Mangan landslide completed under LRMS project of NDMA & SSDMA.

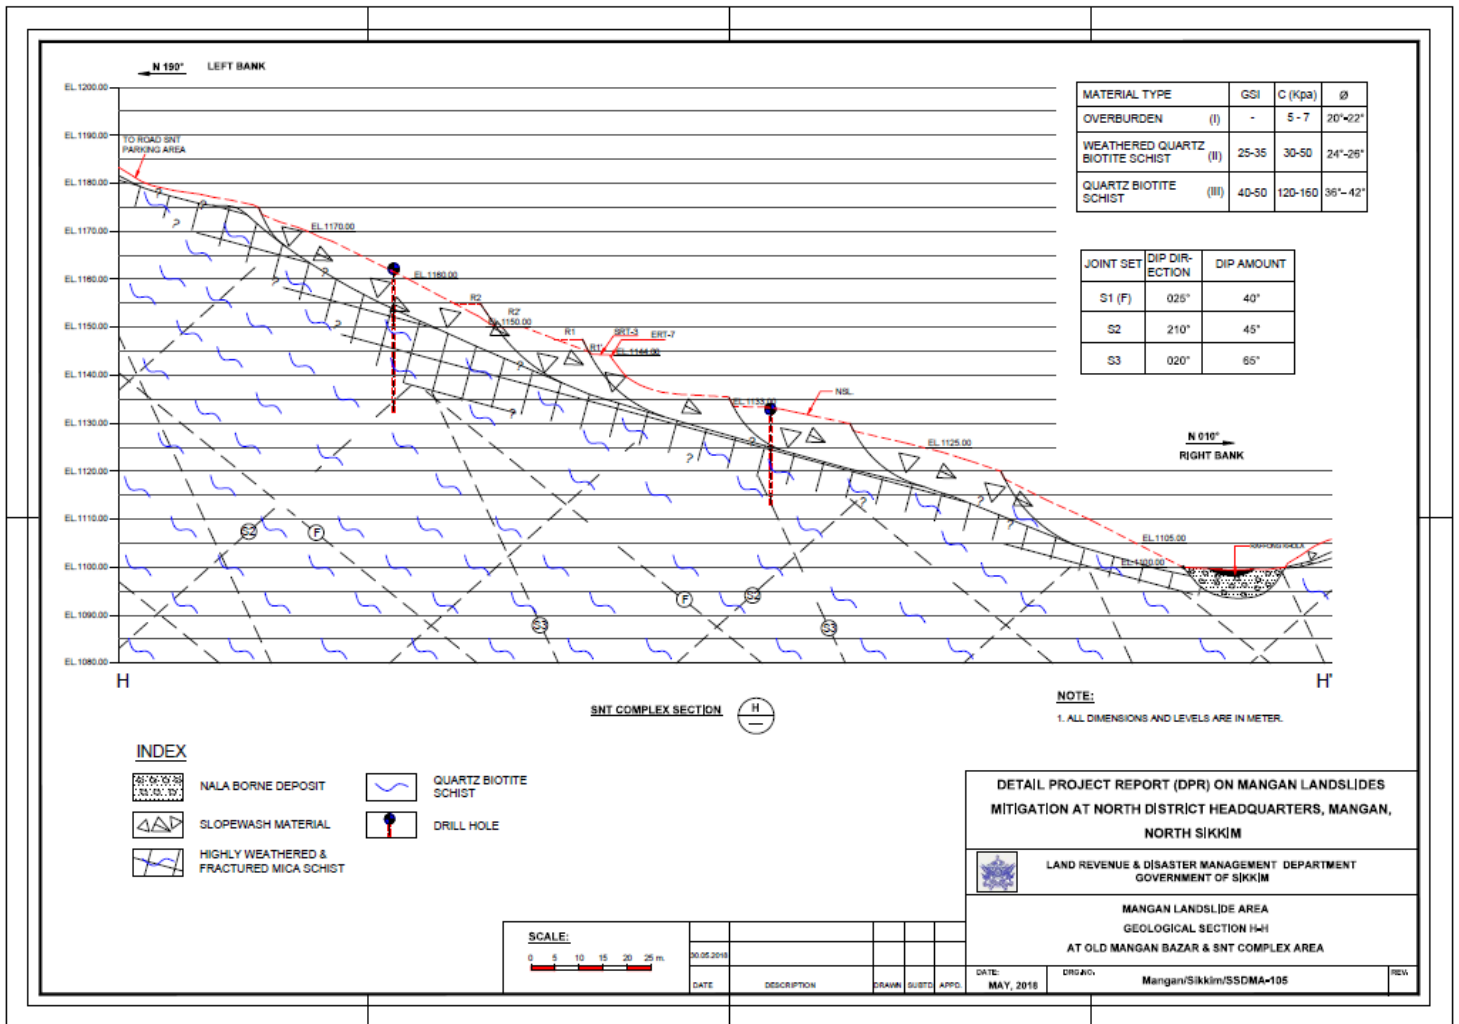
Geological Section at Old Mangan Bazar & SNT Complex Area

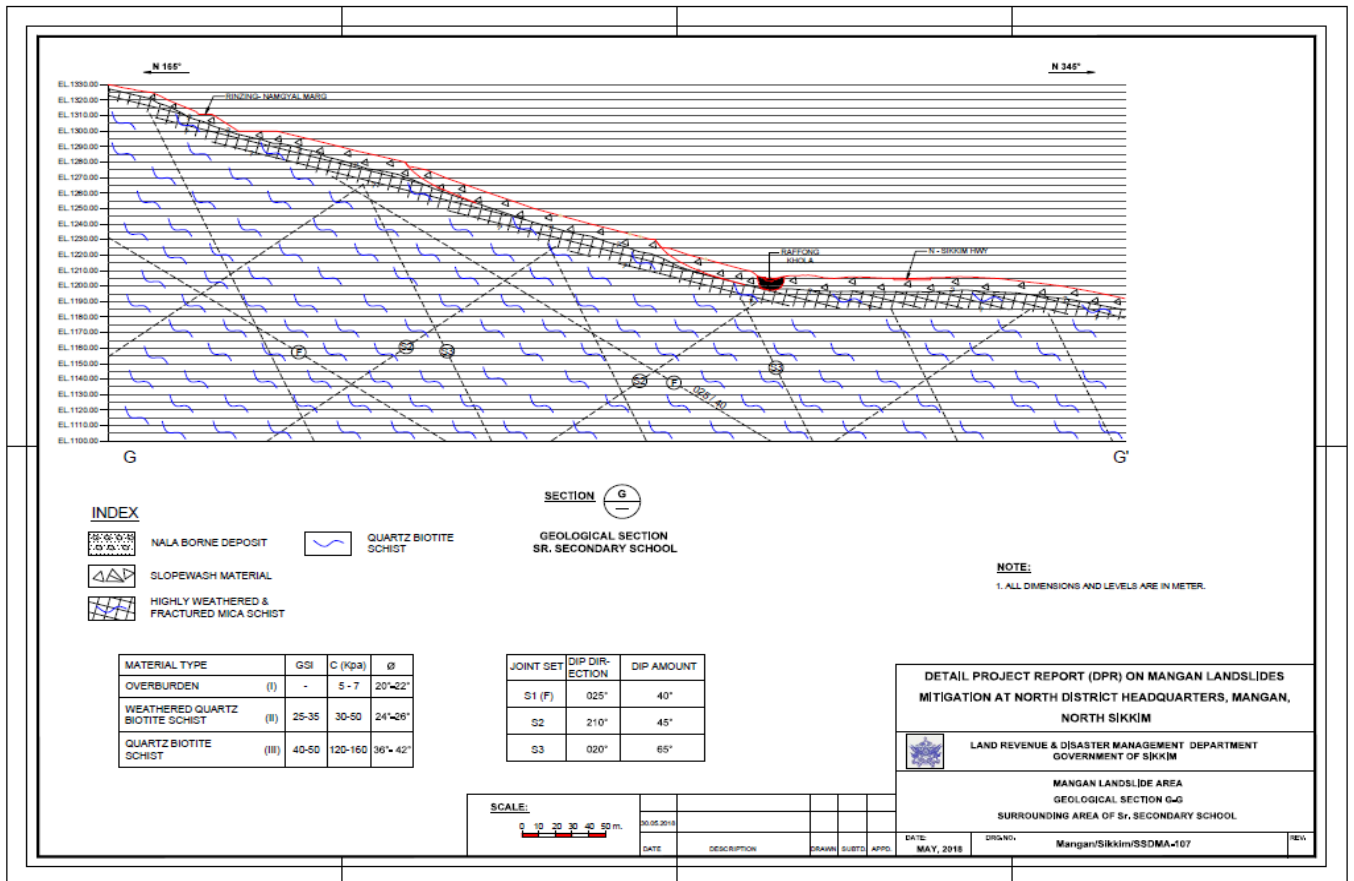
Geological Section of Surrounding Area of Sr. Secondary School
